BUILDING ENVELOPE EVALUATION

ROSEDALE GARDEN - 888 HAMILTON ST, VANCOUVER

207vR007A/a

September 1 , 2007

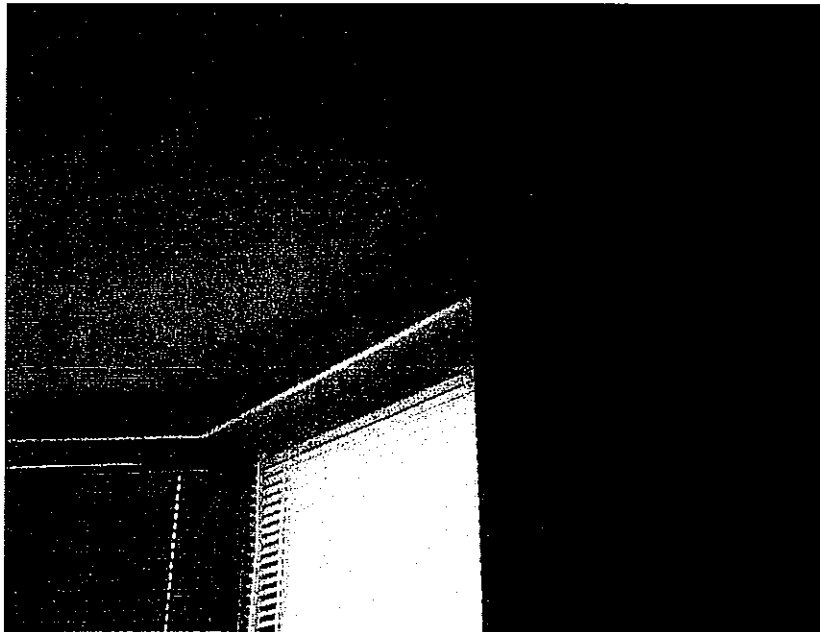
Photo 2: Ceiling water staining at Suite 2305. There is an open joint in the exterior of the window wall above this location allowing water ingress.

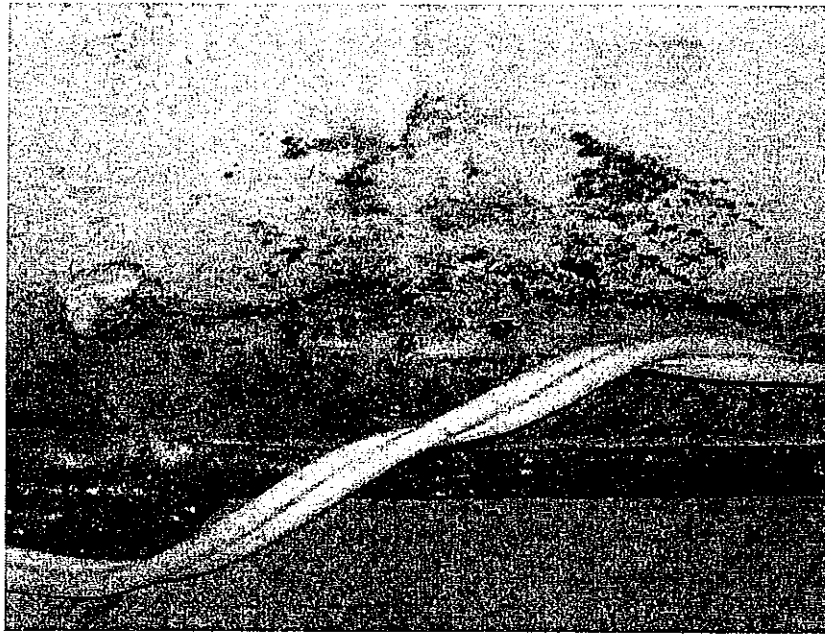
Photo 3: Suite 1201: Black mould like staining on interior drywall below a window.

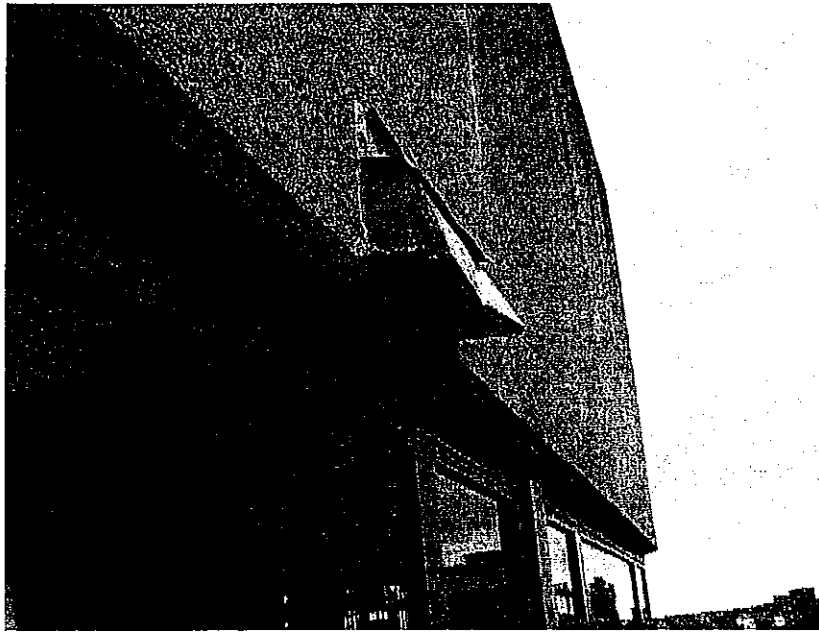
- ▶ **Satisfactory Condition:** The concrete clad walls on the north, south and west elevations of the highrise building appear to be functioning as intended. Minor cracks in the concrete walls and acrylic coating, do not appear to be resulting in water ingress.
- ▶ **Damaged Vent Hoods:** Some vent hoods have impact damage, likely as a result of window washing activities (Refer to Photo 5).

Photo 5: Impact damage to some vent hoods.

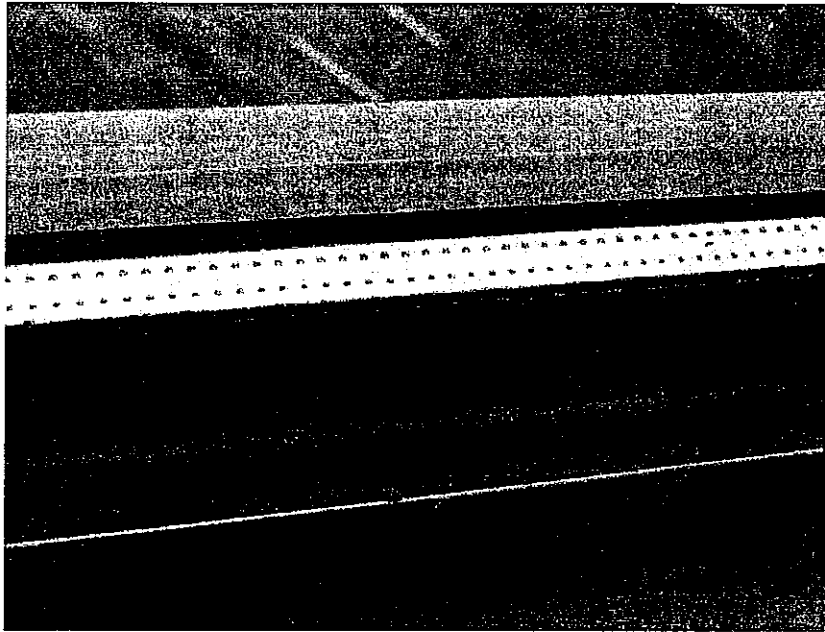
Photo 7: Typical mildew growth in the condensation track of most windows reviewed.

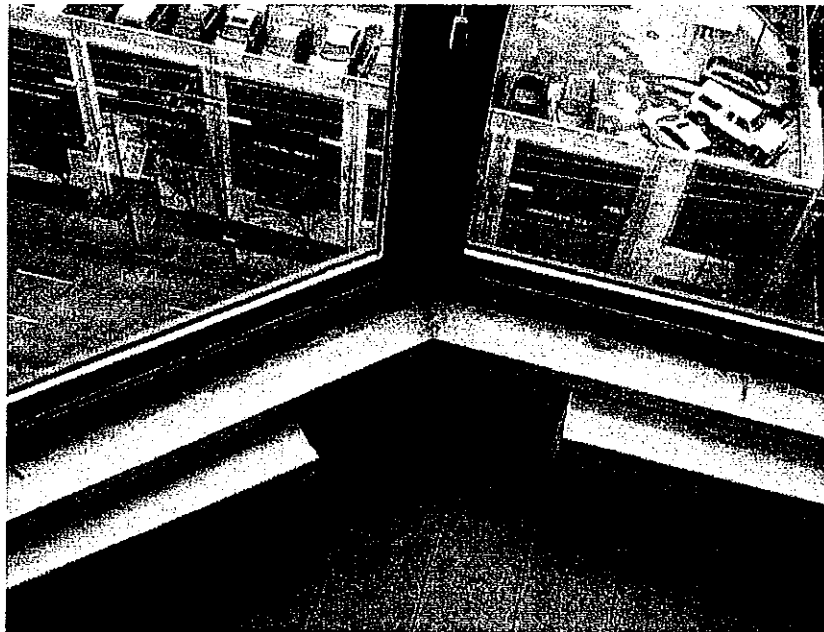
Photo 8: Black staining and water damage common at many windowsills.

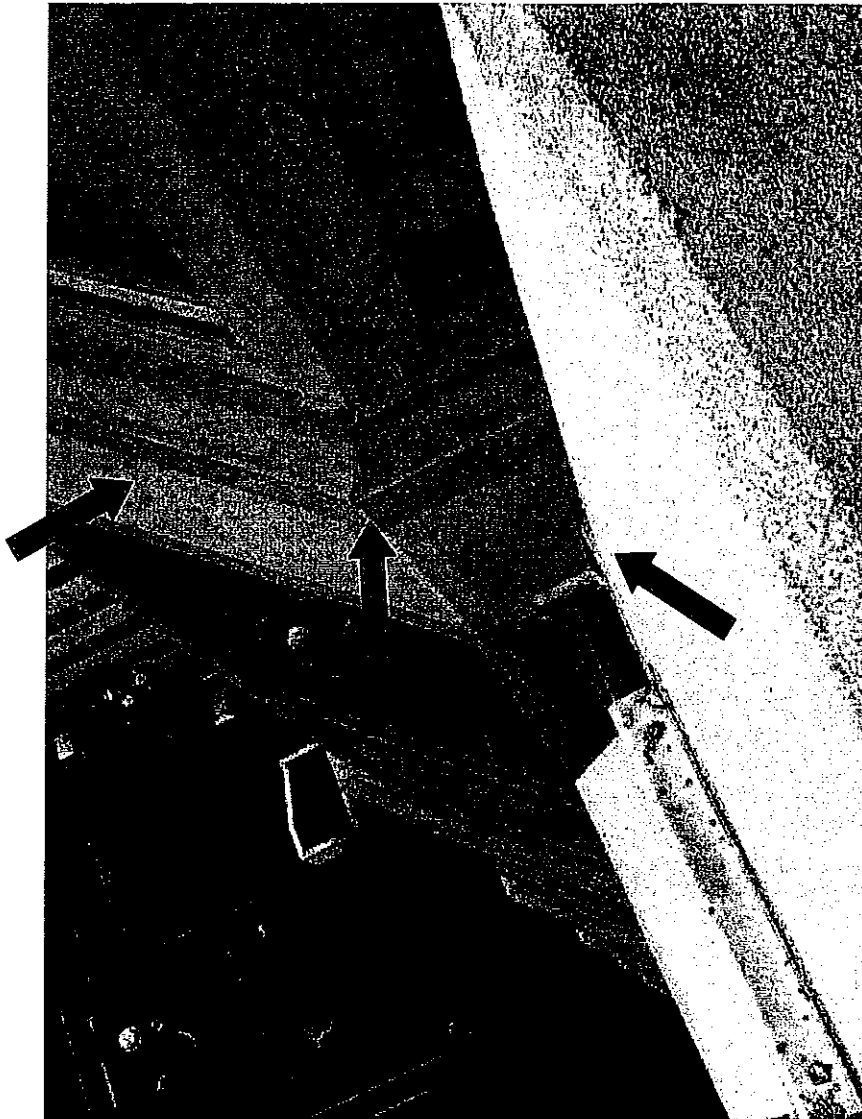
Photo 9: Open joints in the window wall allow excessive amounts of water into the system.

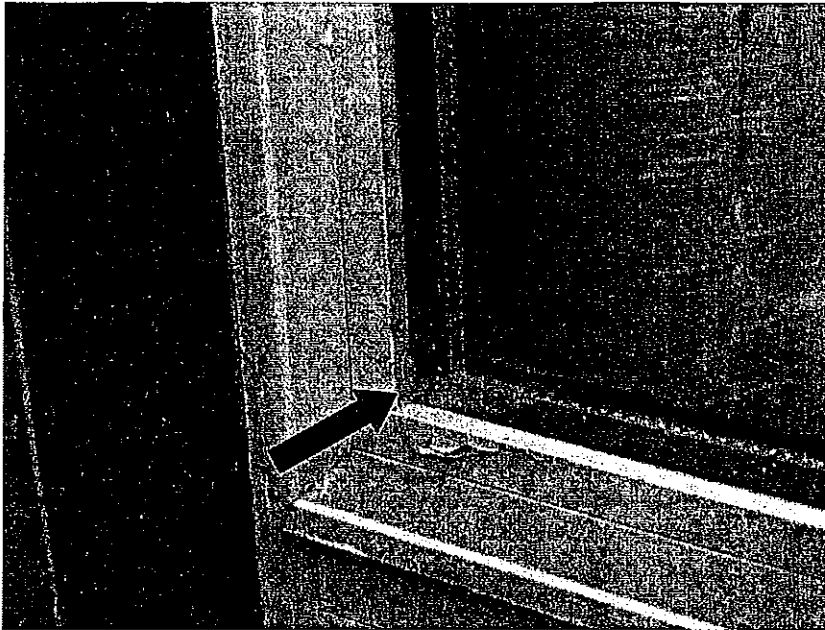
Photo 10: Typical open joint in rubber gasket allows excessive water into window assembly.

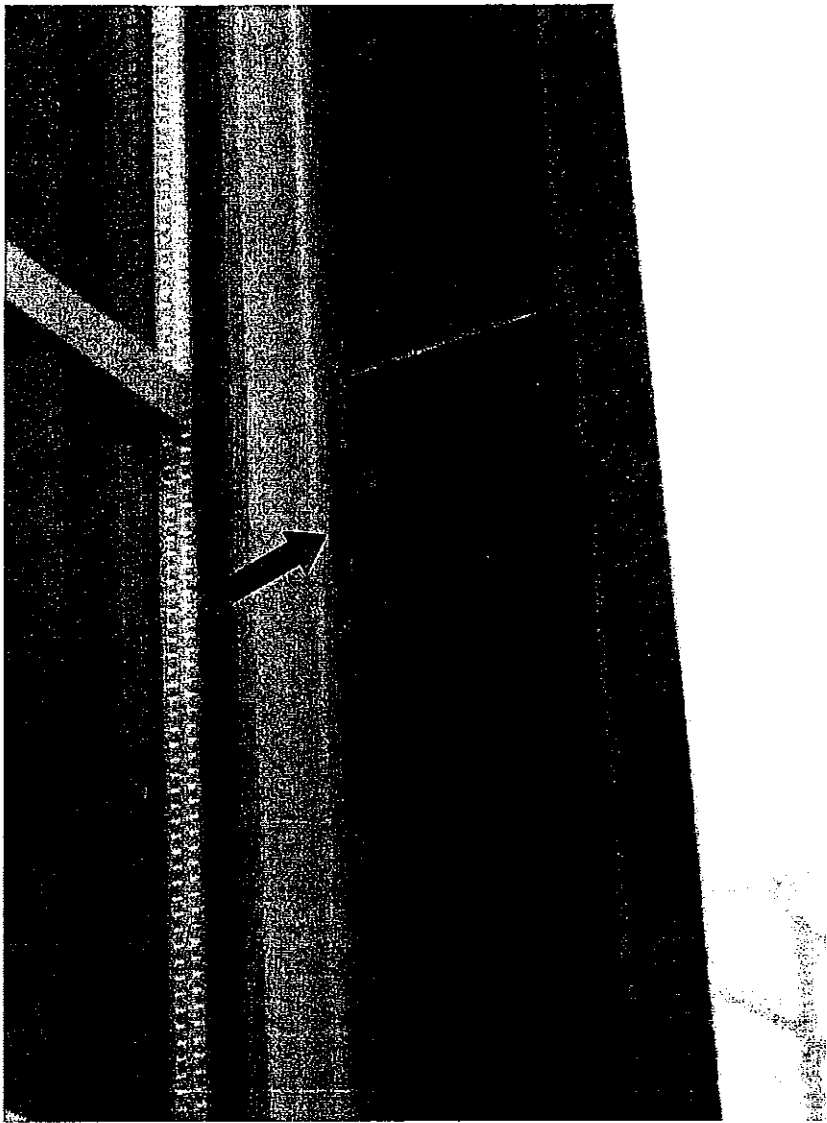
- ▶ *Deteriorating and Failed Sealants:* Sealants around windows and vents, at EIFS joints, and at interfaces between window walls and concrete walls have aged beyond their effective service life (Refer to Photo 11) or have failed as a result of poor sealant profile or inadequate surface preparation (Refer to Photo 12).

Photo 12: Sealant profile is typically too thin causing joint failure.

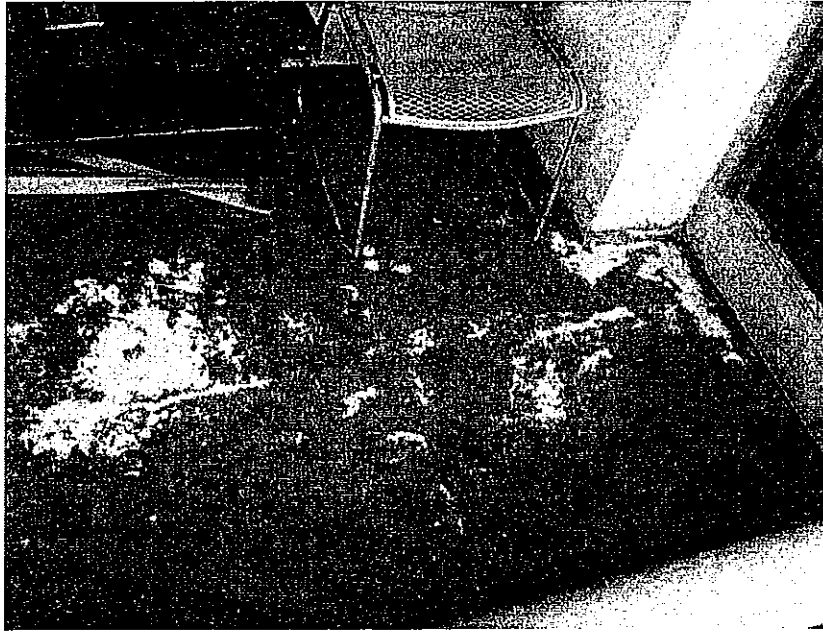
- ▶ *Lack of Membranes:* There are no waterproofing membranes installed on the top surface of the balcony slabs (Refer to Photo 13). Where reviewed, the top surface of balconies are either painted with an exterior grade paint or are covered with tile. Despite the lack of membrane, no leakage has been reported or observed. The lack of damage is likely the result of the shelter provided by balconies above.

Photo 13: The top surfaces of balconies are typically not protected with a waterproofing membrane to protect slab reinforcing from moisture. Balconies are covered with an exterior paint.

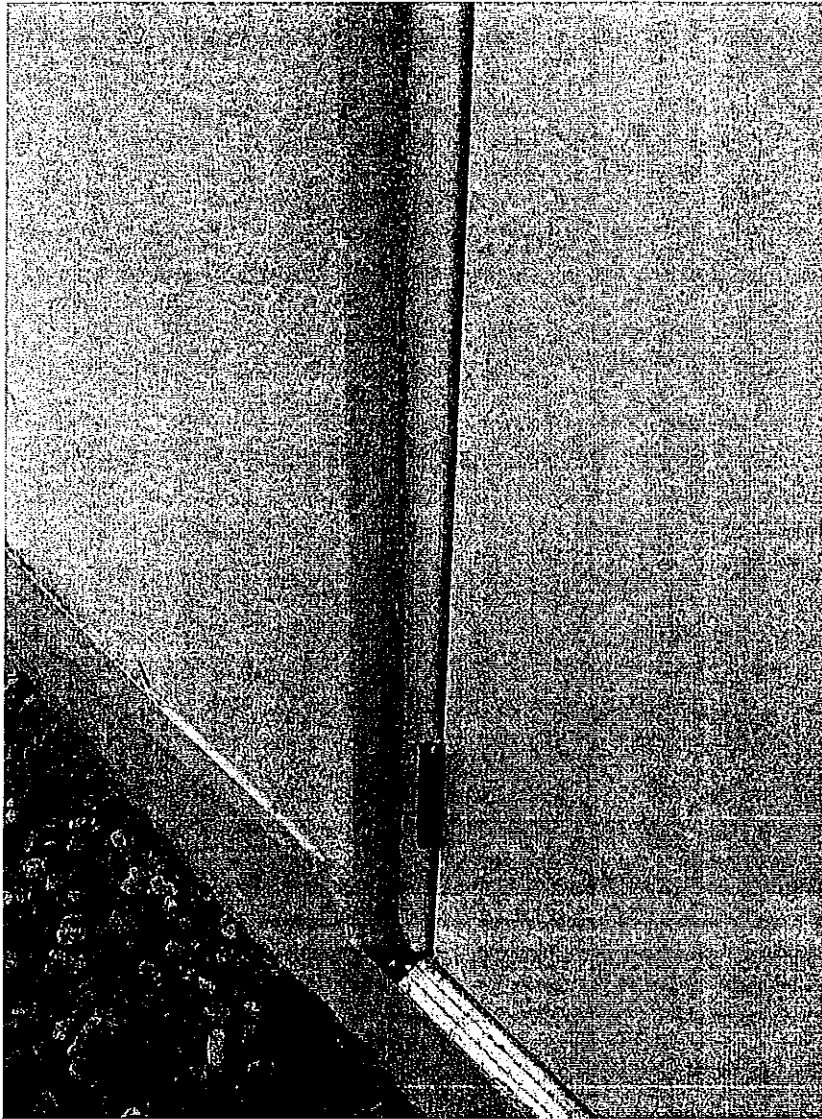
- ▶ *Leakage Around Mechanical Room Doors:* There is evidence of leakage around the mechanical penthouse doors. The door frames are rusting at unsealed joints between the frames and the walls (Refer to Photo 14). The roofing membrane may also be locally failed near this location.

Photo 14: Rusting around roof access doorframe. There is also evidence of water ingress at the building interior at these locations.

- ▶ Localized repairs to the main roof near the mechanical room door;
- ▶ Improve slope to drains at terrace areas. This work could be most cost effectively completed when the terrace membrane requires replacement; and
- ▶ Stucco and tile repairs at townhouses.
